Grounding of Bulk Carrier *John J Boland*

Figure 1. *John J Boland* discharging cargo from its port side using its self-unloading boom in Lorain, Ohio, after the grounding.

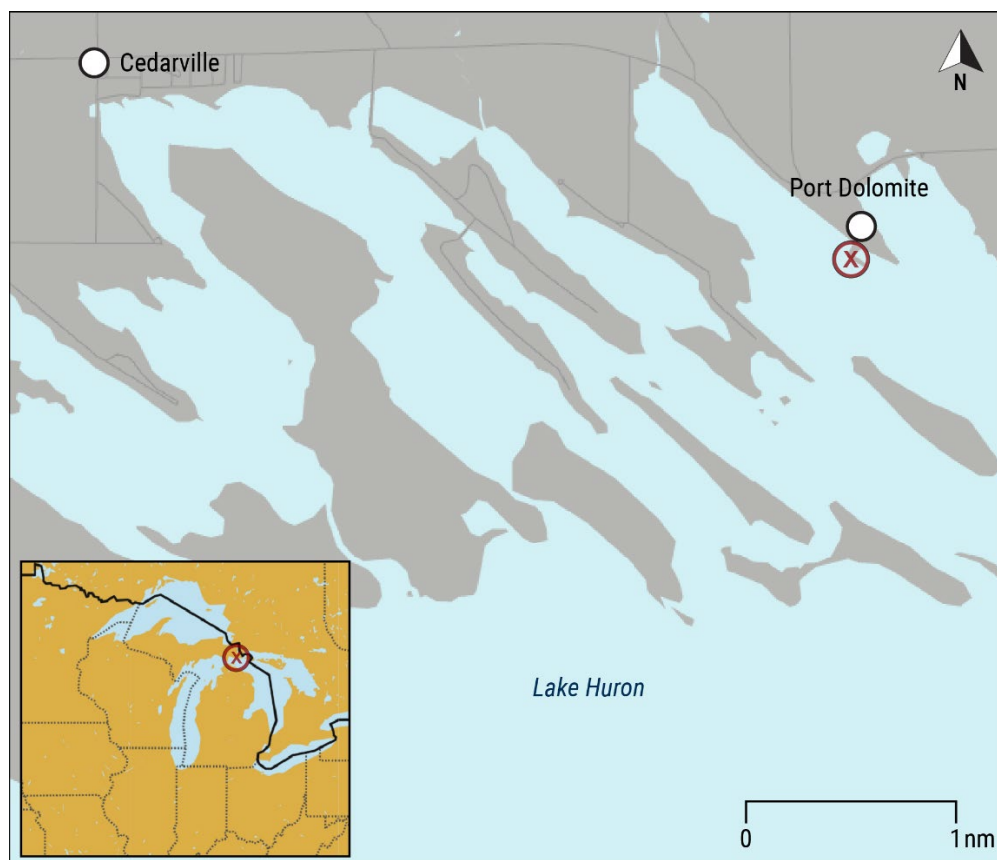
Figure 2. Area where the *John J Boland* grounded, as indicated by a circled X. (Background source: Google Maps)

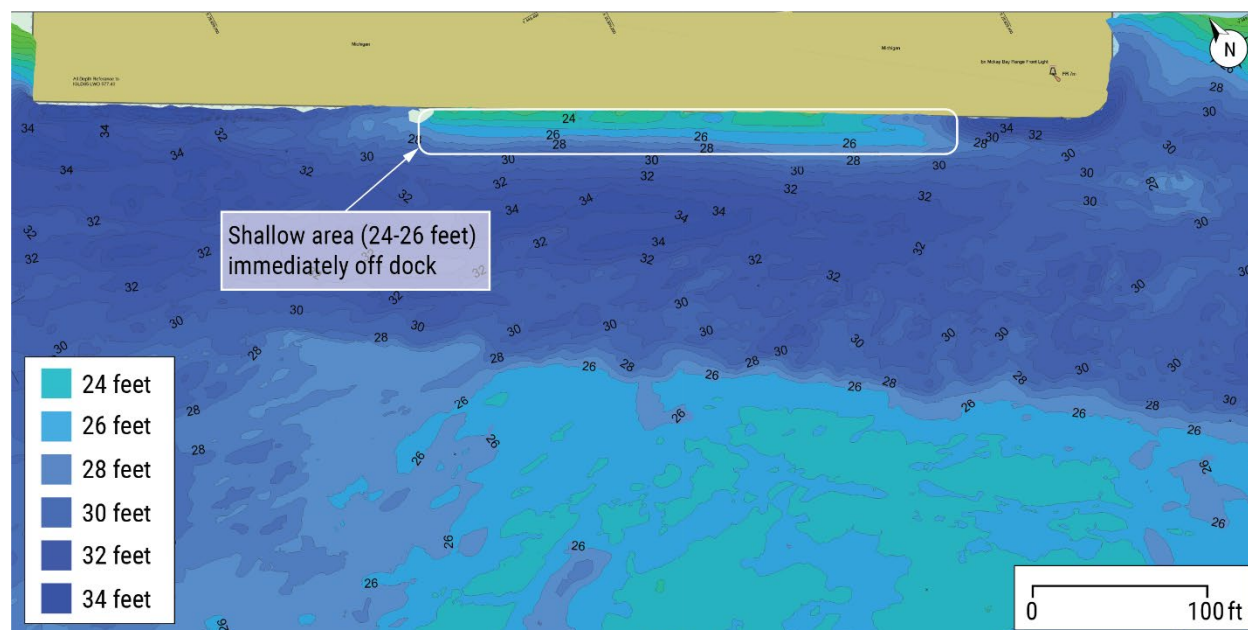
Figure 6. May 8, 2023 (16 days after grounding) bathymetric survey of Cedarville dock (at International Great Lakes Datum). (Background source: Ryba Marine Construction Co.)

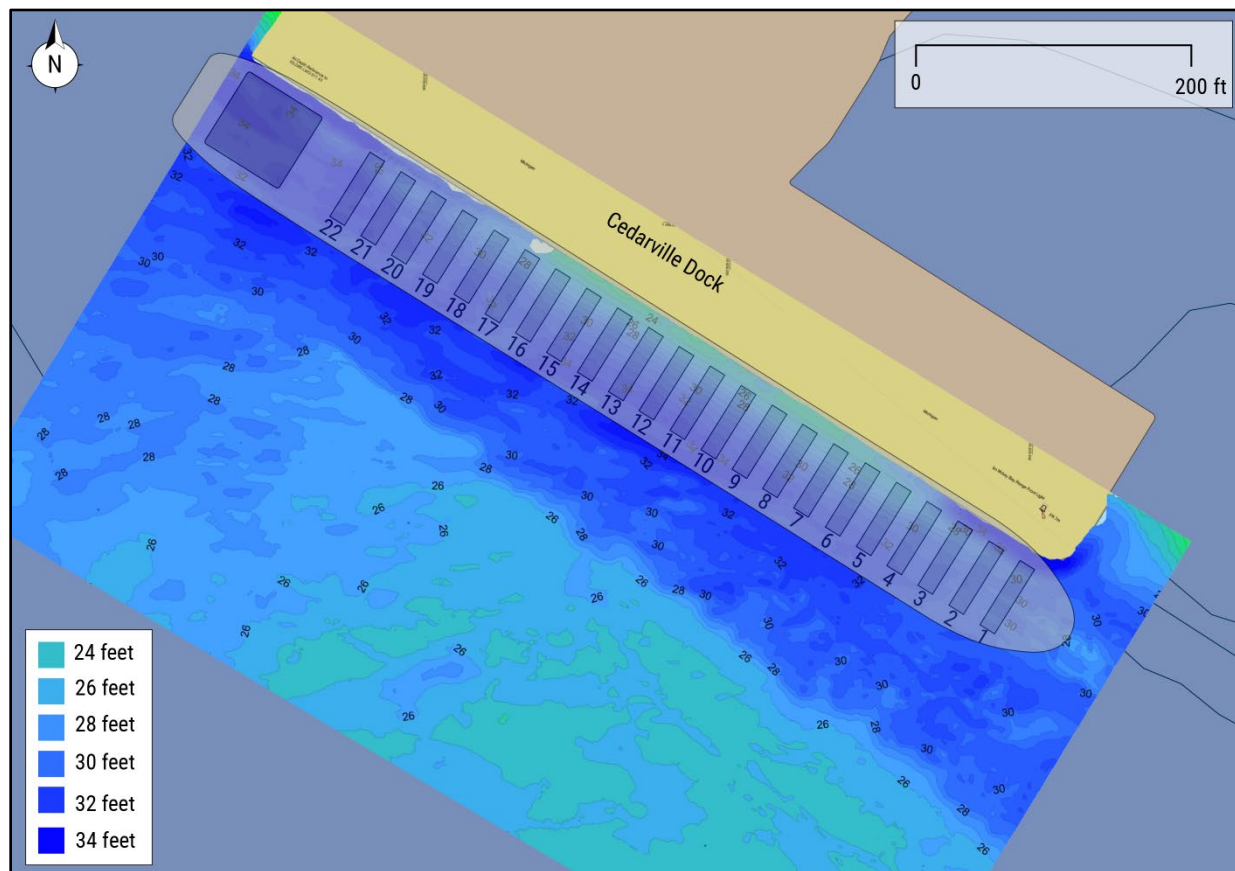
Figure 7. Overlay of *John J Boland*'s position at 0946 after the vessel initially grounded over the 2019 bathymetric survey of the Cedarville dock, which was based on International Great Lakes Datum at Low Water Datum. (Background sources: NOAA Electronic Navigation Chart US5MI53M, Ryba Marine Construction Co.)
