January 22, 2025

MIR-25-04

# Engine Room Fire aboard Fishing Vessel *Three Girls*

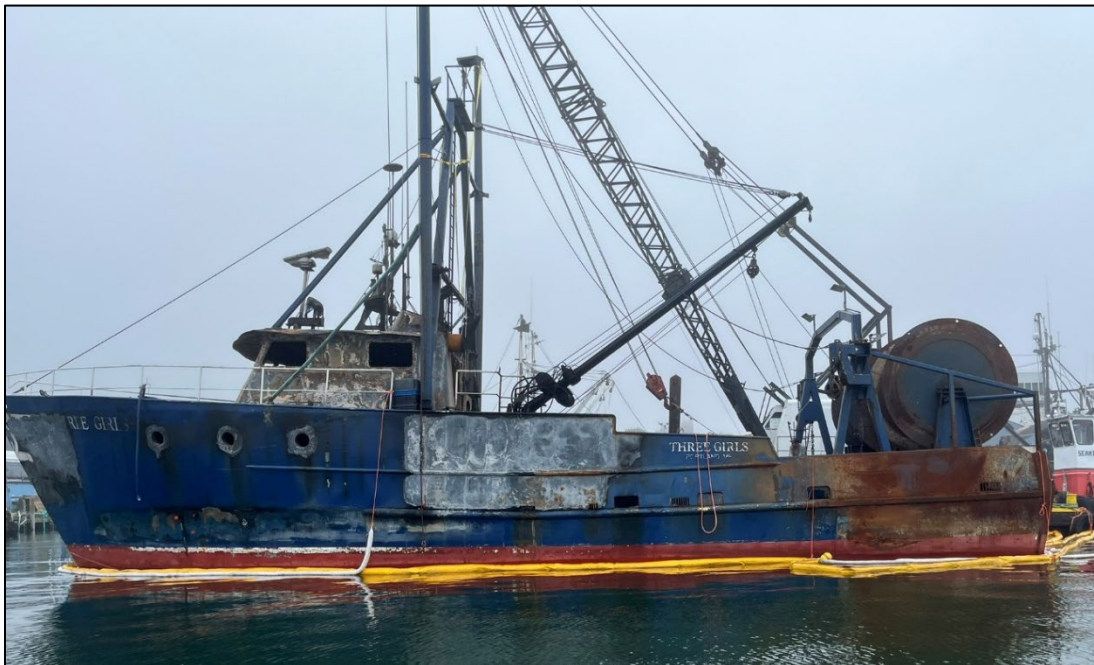
**Figure 1.** *Three Girls* docked in Portland, Maine, on August 14, 2024, after the fire.

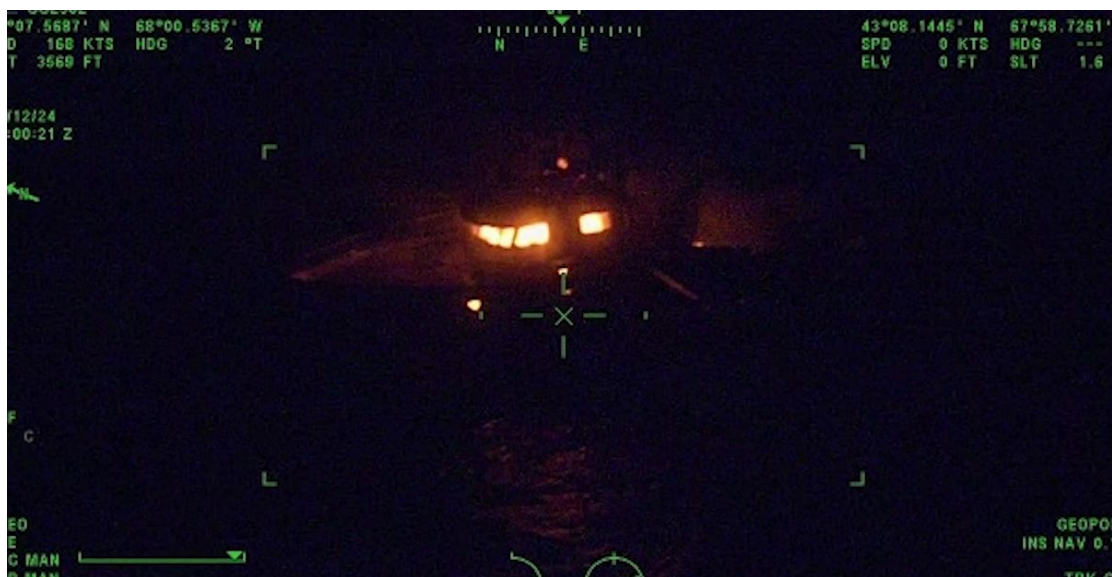
**Figure 4.** View of the burning *Three Girls* from the rescue helicopter, with fire in the wheelhouse. (Source: Coast Guard)

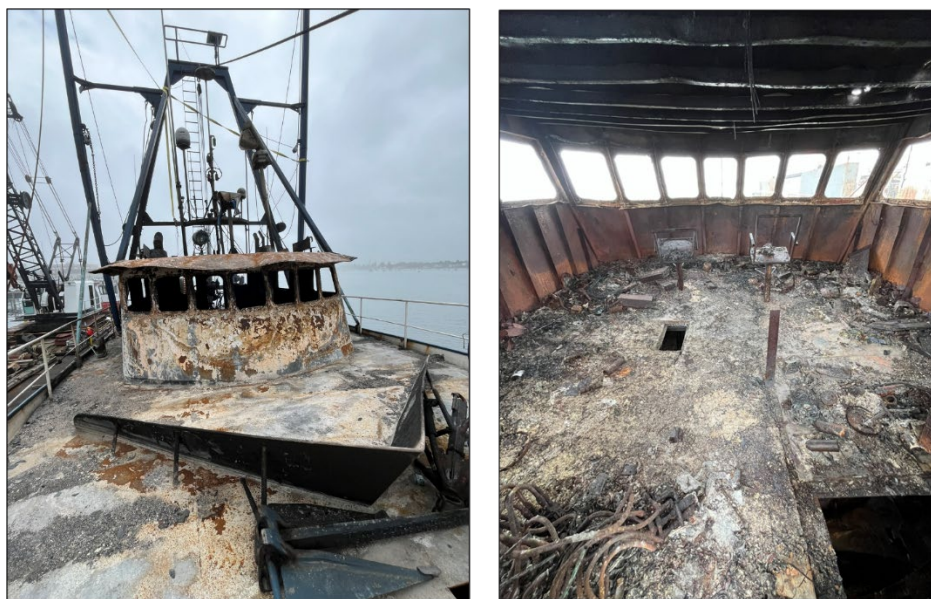
After the fire was extinguished, National Transportation Safety Board and Coast Guard investigators boarded the *Three Girls* to inspect the damage. The Coast Guard also requested assistance from a local Bureau of Alcohol, Tobacco, Firearms and Explosives (ATF) certified fire investigator, who participated in the examination of the damage. The steel bulkheads, decks, and overhead of the wheelhouse displayed several areas of deck and bulkhead warpage, and all contents inside the wheelhouse had been completely consumed by the fire (see figure 5). Below the wheelhouse, all contents of the accommodation spaces were also completely consumed. Additionally, all internal bulkheads, frames, doors, furniture, and equipment were completely consumed by the fire on this deck (accommodation bulkheads and framing were comprised of white fiberglass-reinforced panels on the bulkheads and overheads with varnished trim, and staterooms had wood bunks and storage cabinets).

**Figure 5.** Left to right: Foredeck of the fishing vessel *Three Girls* after the fire, and fire damage to the interior of wheelhouse after the fire.

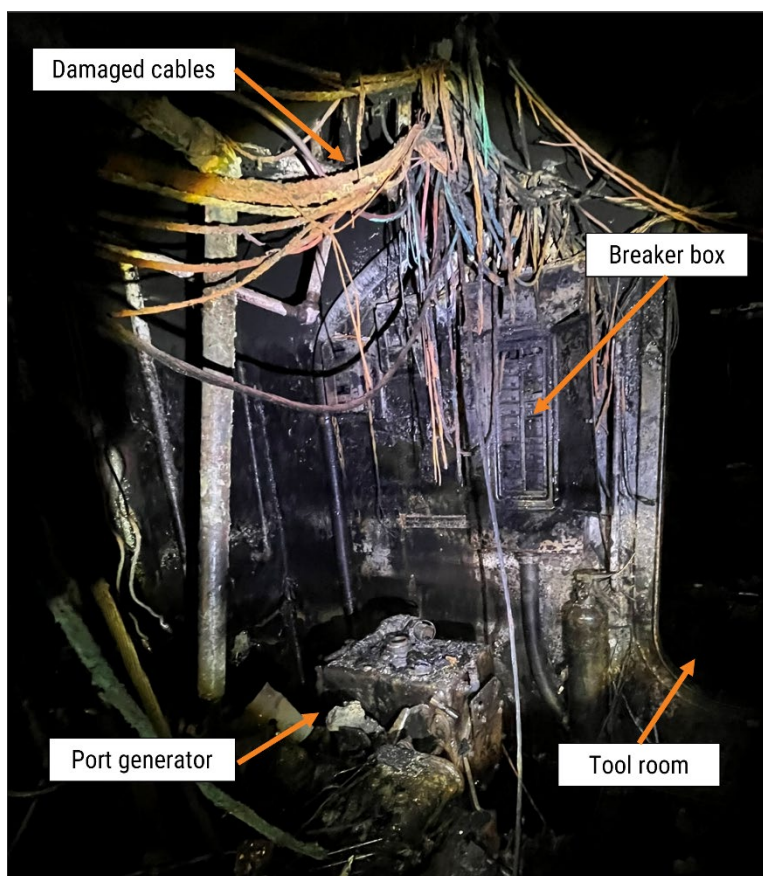
In the engine room, the greatest extent of damage was in the forward, port corner of the engine room above the walkways, which were comprised of plywood decking on steel framing (see figure 6). This section of the engine room exhibited heavy fire damage and sustained significantly more damage than the starboard side of the engine room. Multiple electrical cables in the overhead were damaged, and all flexible hoses and connections were consumed. Several electrical breakers were melted within their breaker boxes in the forward part of the engine room. All exposed surfaces were heavily sooted; a few areas of “clean burn” were present between the winch engine exhaust piping and the hydraulic filter housing in the overhead above the port generator.<sup>6</sup> The lower portion of the main engine crankcase and all machinery in the bilge were undamaged by the fire, and the exterior paint coating was still intact.

**Figure 6.** Fire damage in the port forward corner of the *Three Girls* engine room.

Coast Guard, ATF, and NTSB investigators' postcasualty examination of the vessel showed substantial damage on all decks. Because the captain reported initially observing fire in the engine room, investigators concentrated their inspection there. In the engine room, the greatest extent of damage was observed in the forward, port corner of the engine room above the walkways (plywood decking above steel framing). The lower portion of the main engine and all machinery below the walkways were undamaged by fire, so the fire had most likely not started below the walkways in the lower engine room. Several exposed surfaces were heavily covered in soot, and there were a few areas of "clean burn" present between the hydraulic return oil filter housing and the winch engine that was operating at the time, indicating the fire had burned hottest there. Therefore, the fire area of origin was likely in the port, forward corner of the engine room between the hydraulic return oil filter housing and the winch engine.

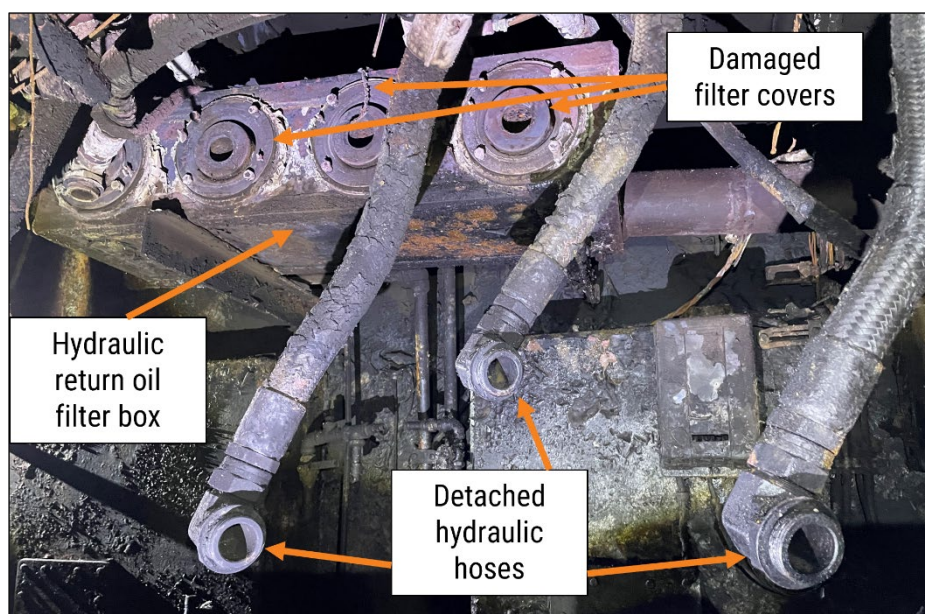
In the engine room, the hydraulic hoses that had been connected to the return oil filter box in the overhead on the port side of the engine room were found detached, and the aluminum filter housing covers were consumed (see figure 7). Several hydraulic hoses throughout the engine room had melted adjacent to their steel connection fittings.

**Figure 7.** Hydraulic system return oil filter box in the *Three Girls* engine room after the fire.

All hydraulic hoses from the hydraulic return oil filter box were found detached from their aluminum filter housing covers, which had been melted away by the fire, indicating the hoses, their fittings, or another component of the box had failed. Due to the extent of the fire damage throughout the engine room, investigators were unable to determine which hydraulic hose, fitting, or component may have initially failed. The integrity of the filter box itself may have been compromised due to the excessive internal pressure that the box had been exposed to before the return pipe was enlarged, which had caused the box to bulge (as observed by the captain 2 years before the fire). If the filter box or a component of the filter box failed, pressurized hydraulic oil would have sprayed into the engine room onto nearby operating machinery. Hydraulic oil is widely used in the marine industry for power transmission and is used under high pressure (2,000–3,000 psi), and the vessel's captain reported this system typically had pressures of 2,200–2,800 psi. When a failure in a hydraulic system causes a breach, such as a ruptured hose or failed fitting, the pressurized hydraulic oil can escape at high velocities and become atomized into an extremely flammable and potentially explosive mist, particularly where ignition sources are present.<sup>8</sup>

The National Transportation Safety Board determines that the probable cause of the fire aboard the fishing vessel *Three Girls* was likely the failure of a component on the hydraulic system (located in the engine room) for on-deck fishing equipment, resulting in pressurized hydraulic oil spraying onto a running engine's exhaust system and igniting.

After an engine room fire ignites, it is imperative to remove the sources of available fuel and ventilation to the fire to prevent it from spreading. Vessel designers, builders, owners, and operators are encouraged to install, regularly test, and have emergency drills that incorporate remote shut offs for all machinery within these spaces to ensure the machinery can be remotely stopped from outside the space where it is situated. Additionally, to prevent the reintroduction of oxygen to the space, vessel designers and owners should ensure that the ventilation, both natural and forced draft, can be completely and remotely secured to all engine rooms.
