April 10, 2025

MIR-25-15

Engine Room Fire aboard Towing Vessel *Johnny M*

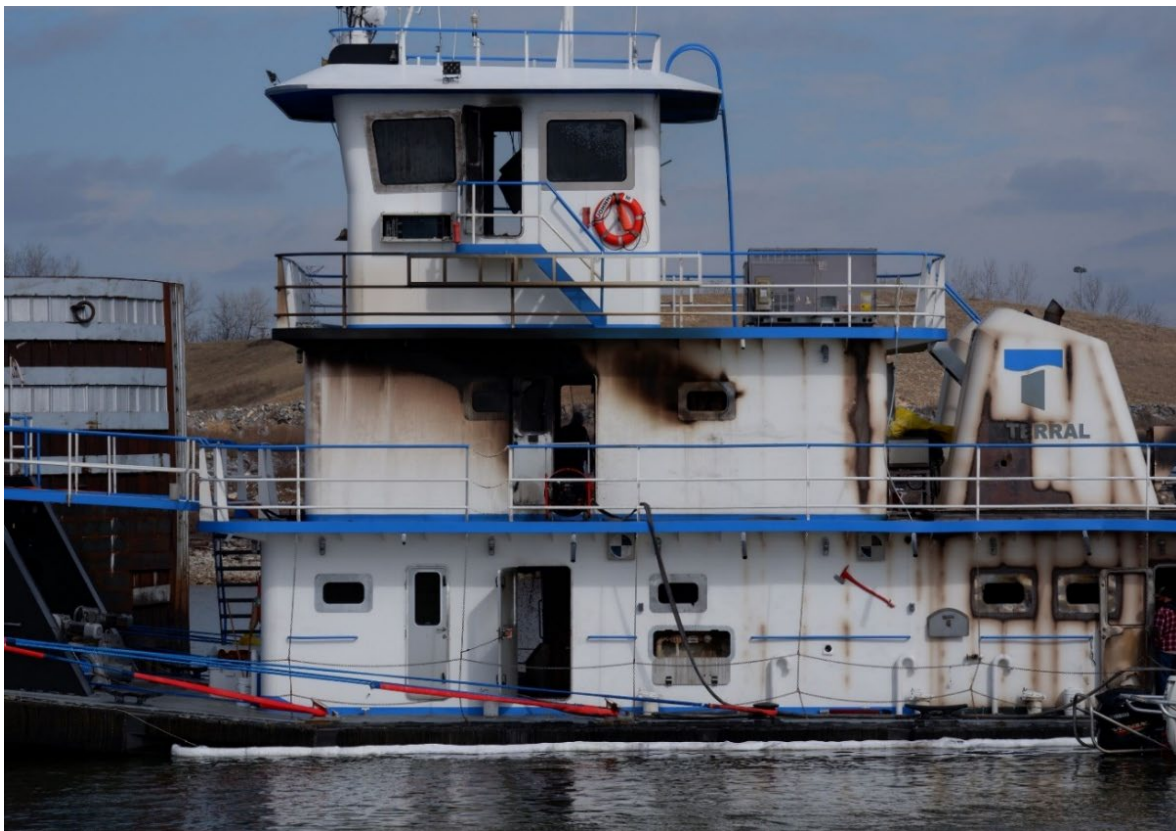
The engine room window frames and the deck above the engine room were warped due to heat exposure (see figure 6). The outboard side of the portside stack

had an area of charred/burned-off paint that corresponded with the location of the port main engine exhaust system. The starboard-side stack did not exhibit this severity of damage.

Figure 6. Portside view of *Johnny M* after the fire, showing fire-damaged portside window on exterior of engine room upper level and portside main engine exhaust stack heat and fire damage. (Source: Coast Guard)

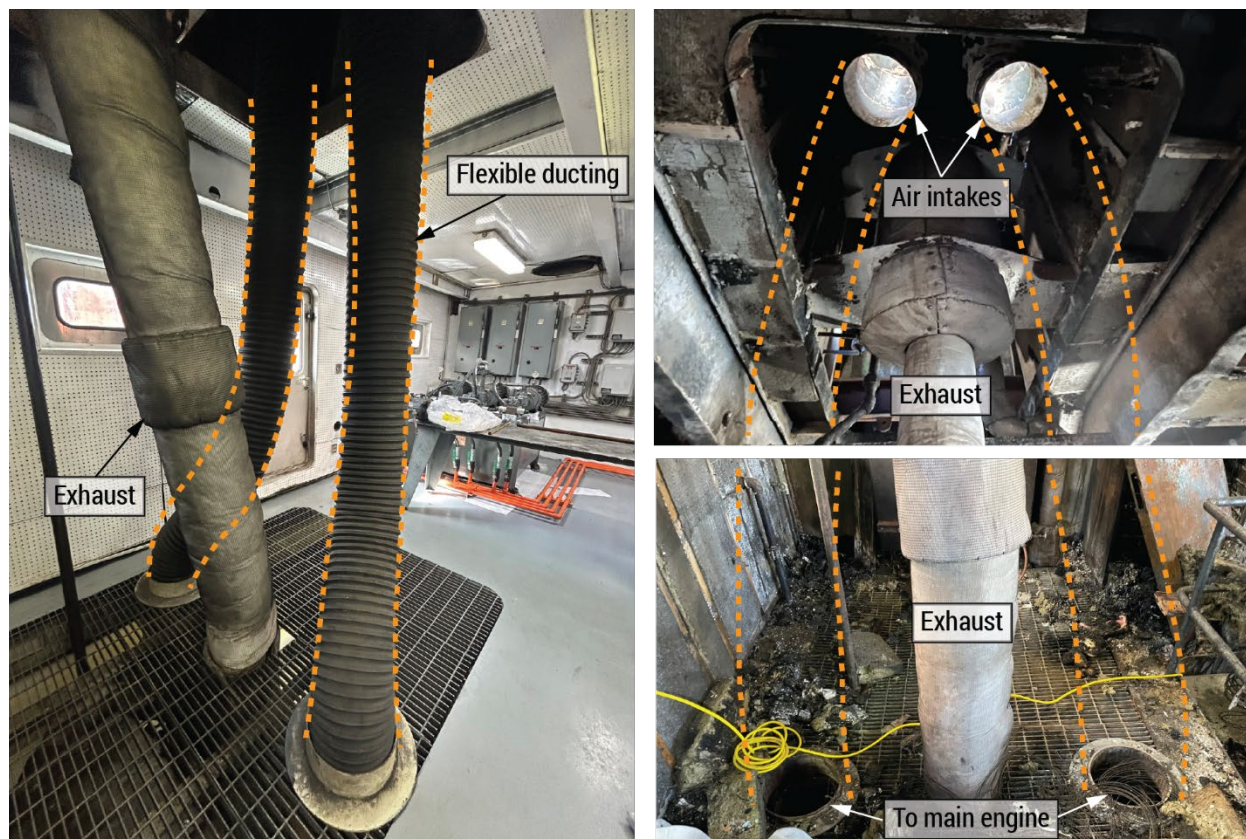
Both the port and starboard main engines' combustion air was supplied through two flexible ducts originating through air intake openings on the upper deck on the aft side of each stack and extending down through the upper level of the engine room and to each engine's turbochargers (see section 1.3.4). A flange adapter affixed to the top of the turbocharger connected the flexible ducting to the top of the inlet of the turbocharger on the aft end of the engine. The fabric material covering the four flexible ducts was incinerated during the fire, leaving only the metal wire helix (backbone) structure (see figure 7). The exterior bulkheads of the engine room, exhaust stacks, and surface of the main deck were severely heat-damaged.

Figure 7. Clockwise from left: Starboard main engine's air combustion air intake flexible ducting on sister vessel *Amy T* (the insulated engine exhaust pipe is shown between the two flexible ducts.). Missing (incinerated) ducting from *Johnny M*'s port main engine after the fire (dashed lines show the approximate location of the ducting). (Background source [left]: Terral RiverService)

During their postcasualty investigation, investigators found that the fire had consumed the flexible ducting for the air intake openings. The flexible ducting was designed to be part of a closed system to provide combustion air to each engine’s turbochargers. However, the flexible ducting was made of combustible material; it was not structurally protected from fire (nor was it required to be).⁵ Therefore, as the ducting was consumed by the fire, it allowed oxygen from outside the vessel to enter the engine room through the uncovered air intake openings and feed the fire. Investigators could not determine when the ducting burned—before or after the crew activated the CO₂ fixed fire extinguishing system (a postcasualty examination of the CO₂ system indicated it had functioned as designed). However, given that the CO₂ was ultimately ineffective in completely extinguishing the fire, it is likely that the ducting burned before or during the activation of the fixed fire extinguishing system. Additionally, nearby combustible materials—the plastic sight glasses for the waste oil and lube oil tanks—would have melted, allowing oil to leak out and further fuel the fire. Fixed fire extinguishing systems in machinery and other hazardous spaces require a minimum concentration of extinguishing agent to either halt the chemical reaction producing the fire, displace the oxygen feeding the fire, or effect a combination of both. To ensure the effectiveness of the system and prevent the reintroduction of oxygen to the space, ventilation (both natural and forced draft) must be completely secured to all fire-protected spaces. Had the vessel been outfitted with covers for the main engine combustion air intake openings or the flexible ducting been made of a fire-resistant or noncombustible material or structurally protected from fire, oxygen likely would not have been able to enter the engine room, and the CO₂ fixed fire extinguishing system likely would have been effective.

The flexible ducting providing combustion air to the main engines on board the *Johnny M* extended from the engine stacks on the main deck down to the engine room and did not have any insulation or other barriers to prevent the passage of smoke, heat, and fire—known as structural fire protection. This type of unprotected ducting has the potential to provide a pathway for fixed fire extinguishing agents, such as carbon dioxide, to escape and air to enter the engine room if the ducting is compromised by a fire within the space. Identifying potentially unprotected openings and ducting into a fire-protected space and incorporating structural fire protection can ensure the effectiveness of a fixed fire extinguishing system and prevent the spread of fire.

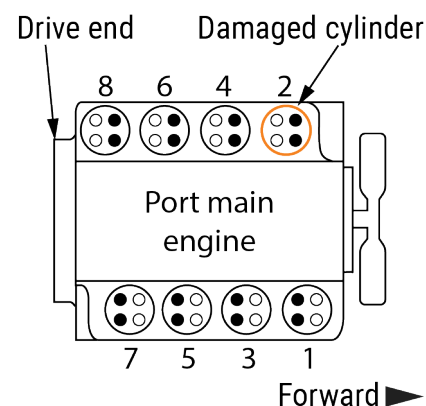
The port main engine was severely damaged during the casualty. The crankcase had ruptured, via the crankcase covers, on the port and starboard sides in the area of the nos. 1 and 2 cylinders (see figure 8). Additionally, components of the engine—including a connecting rod bearing cap—were found outside the engine. The engine block in the area around the crankcase covers of the nos. 1 and 2 cylinders was also damaged. The larger of the crankcase holes and most of ejected components were located on the port side of the engine.

Figure 8. Diagram of port main engine showing location of damaged cylinder no. 2.

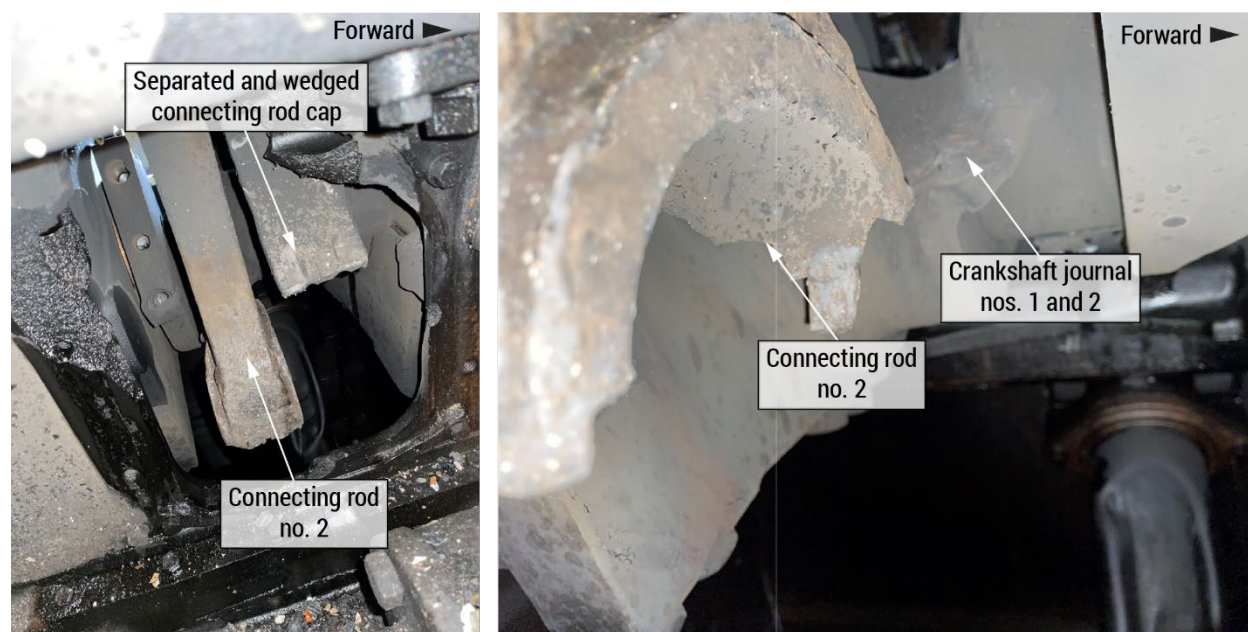
Inside the engine, both the nos. 1 and 2 connecting rods were found to be disconnected from the crankshaft and their bearing caps separated (see figure 9). One of the connecting rod caps was forcibly wedged between the cylinder liner and crankcase directly above the damaged area of the crankcase (engine block). The crankshaft showed signs of what appeared to be both impact and thermal damage to the nos. 1 and 2 journals. The crankshaft webs in that area were also damaged, as was the lube oil sump suction tube.

Figure 9. Left to right: Damage to the port main engine connecting rod and crankcase.

A postcasualty examination of the vessel found that the port main engine was severely damaged. A report completed by a marine surveyor attributed the fire to the port main engine base “exploding.” Investigators found the nos. 1 and 2 connecting rods were forcibly separated from the crankshaft and their bearing caps broken off. Investigators attempted to determine the cause of the connecting rod failure. There were no indications that the port main engine was overloaded leading up to the casualty. Additionally, given that the port main engine had been overhauled about 7 months before the fire, with new components and bearings installed, excessive wear of engine components was likely not a reason for the connecting rod failure. Although the wheelhouse log noted the crew had “stopped to check [the] port main [engine]” the day before the fire, the operating company and crew did not provide additional information about this logbook entry. Neither the vessel owner nor the engine manufacturer completed a forensic examination or disassembly of components of the port main engine after the casualty. Therefore, investigators could not definitively determine why the connecting rod failed.

Pieces of the bearing caps for the disconnected nos. 1 and 2 connecting rods were found forcibly wedged between sections of the engine crankcase, in the immediate area, and the surfaces of the crankshaft journals were deformed, indicating the engine continued to run and the crankshaft continued to turn after the connecting rods had become disconnected. Parts from the disconnected connecting rods (including the bearing caps) would have collided randomly and chaotically as the crankshaft continued to turn, damaging other internal engine components—such as the crankshaft journals—blowing open the crankcase covers, and rupturing the crankcase (as the marine surveyor noted in his report). Hot, atomized lube oil would have vented through the openings. After the casualty, the outboard side of the port main engine showed signs of elevated temperatures. Therefore, the catastrophic engine failure likely resulted in the venting and ignition of hot atomized lube oil through the openings of the damaged port main engine.

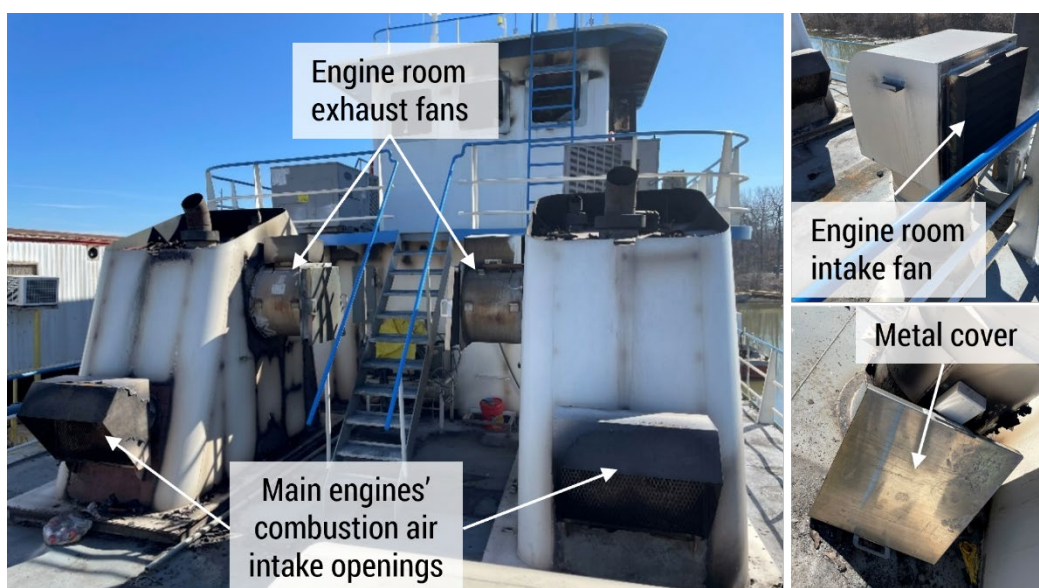
Eight structural ventilation openings provided combustion air to the two main engines and ventilation to the engine room (see figure 10). There were two engine room supply fans, independent of the stacks, located aft on the upper deck, one on the port side and the other on the starboard side. There were two engine room exhaust fans located on the stacks' inboard sides. Each main engine drew in fresh air for combustion from outside the vessel via air intake openings on the engine's corresponding stack (four openings in total); these openings connected to fabric-covered flexible ducting that extended down to each respective engine's turbocharger. The two combustion air intake openings for each engine were housed under a single metal hood (one hood on each stack's lower aft side).

Figure 10. Clockwise from left: *Johnny M* exhaust stacks showing covered engine room exhaust fans and engine air intake openings (two openings under each hood); engine room intake fan (there were two intake fans—one port and one starboard); and metal cover, all located on upper deck.

The engine room intake and exhaust fans could be blocked with metal covers to prevent air from entering the space (the covers were intended for emergency use with the CO₂ fire extinguishing system). Unlike the other ventilation openings on the main deck, the main engine air intake openings did not have metal covers.

According to the captain, on the day of the fire, he put the four metal covers on the ventilation openings, including the engine room intake fans and exhaust fans. During the postcasualty examination of the vessel, investigators found all four main engine air intake openings uncovered.
