June 12, 2025

MIR-25-24

## Fire aboard Fishing Vessel *Tarka II*

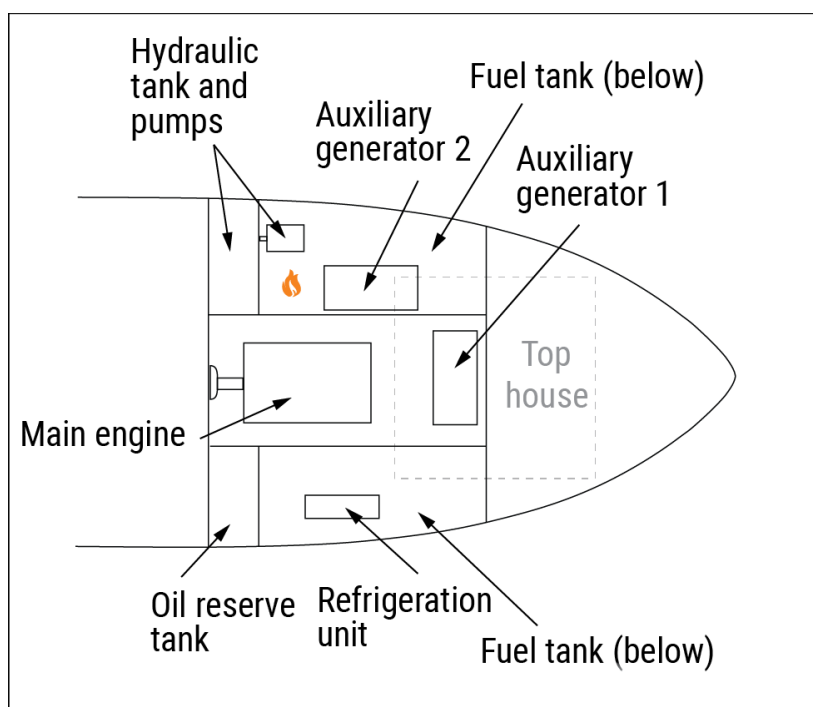
**Figure 3.** General layout of the *Tarka II* engine room (not to scale) with the location of the fire indicated by the flame symbol. (Background source: *Tarka II* captain)

Despite poor visibility from the smoke, the captain manually shut down the no. 1 auxiliary generator and main engine. Afterward, the lights in the engine room went out, and the captain noticed a smoldering fire on the port side near the vessel's hydraulic tank, hydraulic pump, and stores of spare gear oil and hydraulic fluid. The captain told investigators that the hydraulic equipment was 1-2 feet from the main exhaust and that hydraulic lines ran "inches" away from it. The hydraulic pump for the crab pot davit was not running or pressurized; however, the hydraulic pump for the steering system was running and its lines (pipes and hoses) were pressurized.

The hydraulic lines for the davit were not pressurized at the time of the fire. However, the steering system's hydraulic lines (pipes and hoses) were pressurized. The captain noted that hydraulic lines ran "inches" from the engine exhaust pipes, which were protected by fiberglass lagging. Investigators were unable to verify the condition or arrangement of the exhaust lagging in the engine room because the vessel sank and there were no photos available of the engine room before the fire. The captain reported that the smoke initially looked and smelled like engine exhaust. It is possible that exhaust pipe heat, or an exhaust leak, either from the main engine or the running no. 1 auxiliary generator, ruptured one of the pressurized hydraulic lines, causing the hydraulic fluid to spray and ignite on a nearby, unprotected hot surface, and spread to nearby combustibles. However, because the *Tarka II* sank and was not recovered, the exact source of the fire could not be determined.

Installation of smoke and fire detectors in spaces that are typically uncrewed when underway, such as the engine room, allows for the earliest detection and notification of a fire, maximizing the time for operators to respond to the fire or take actions to abandon the vessel. Vessel operators can improve fire safety by installing detectors in all areas susceptible to fire (such as the engine room and galley, and spaces that contain machinery, hot exhaust tubing, and fuel sources). Additionally, the detectors should be capable of notifying crewmembers throughout the vessel of fire or smoke and be routinely checked to ensure they are in good working order.

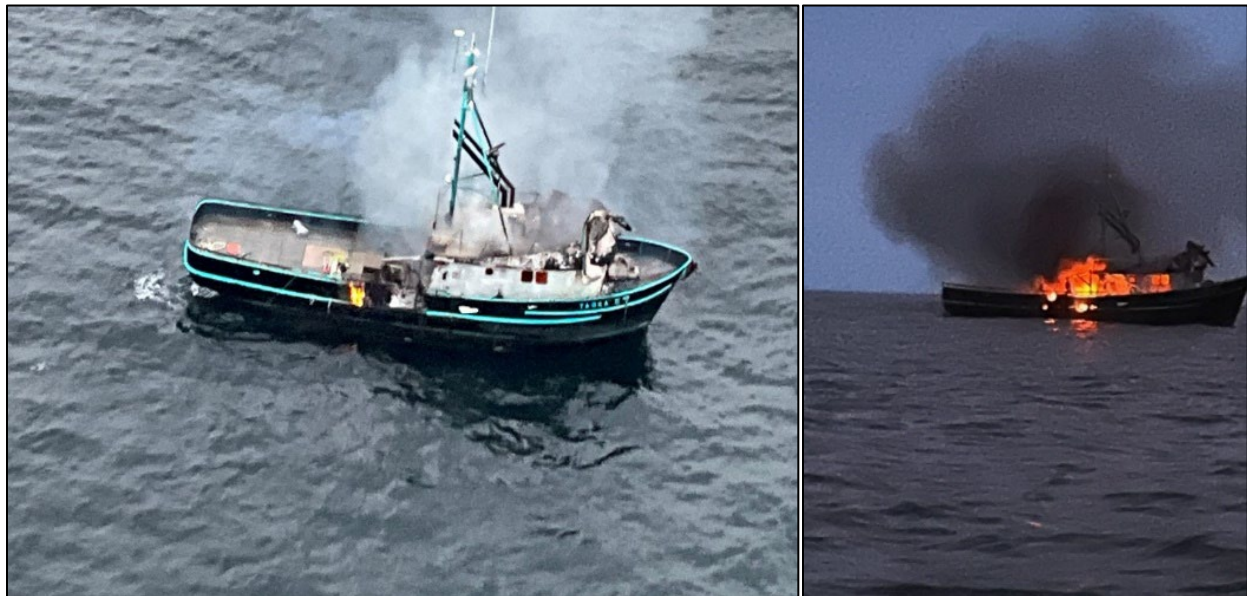
Later that evening, at 1903, a Coast Guard helicopter from Air Station Port Angeles conducted an overflight of the *Tarka II* to observe the condition of the vessel and mark its location. Around 2000, the captain returned to the *Tarka II* on another vessel and saw "a huge fire" from the engine room "all the way up to the top house" (see figure 4).

**Figure 4.** Left to right: The *Tarka II* as seen on the Coast Guard overflight and the *Tarka II* as seen by the captain upon returning to the vessel, both on the night of the fire. (Sources: Coast Guard, *Tarka II* captain)
