August 6, 2025

MIR-25-32

Grounding of Barge *Cordova Provider*

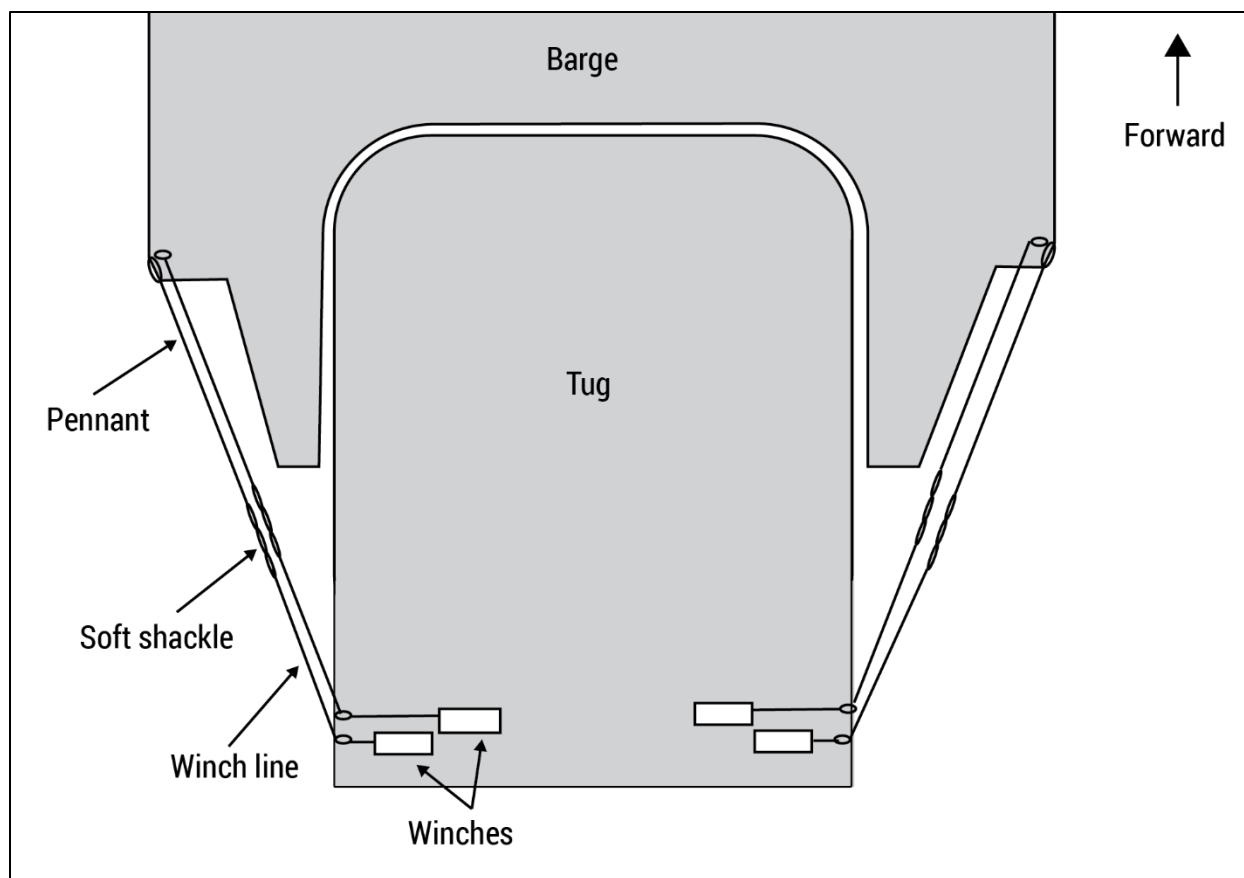
Figure 3. Simplified drawing of the integrated tug and barge, showing the makeup, arrangement, and location of the push lines connecting the tug to the barge. Scale approximate. (Background source: Bering Marine Corp)

At the time of the casualty, the *Krystal Sea* and the *Cordova Provider* were connected by four synthetic push lines, each comprised of a 1-inch-diameter, 12-strand winch line; a 0.75-inch-diameter soft shackle; and a 1-inch-diameter, 12-strand pennant. The breaking strength of the 1-inch line was 96,390 pounds, and the breaking strength for the 0.75-inch soft-shackle line was 101,000 pounds.

In addition, the three eyes on each push line were covered with double-braided jacketing that extended 4 feet on the line to protect against chaffing. The soft shackles in the push lines were not covered with double-braided jacketing.

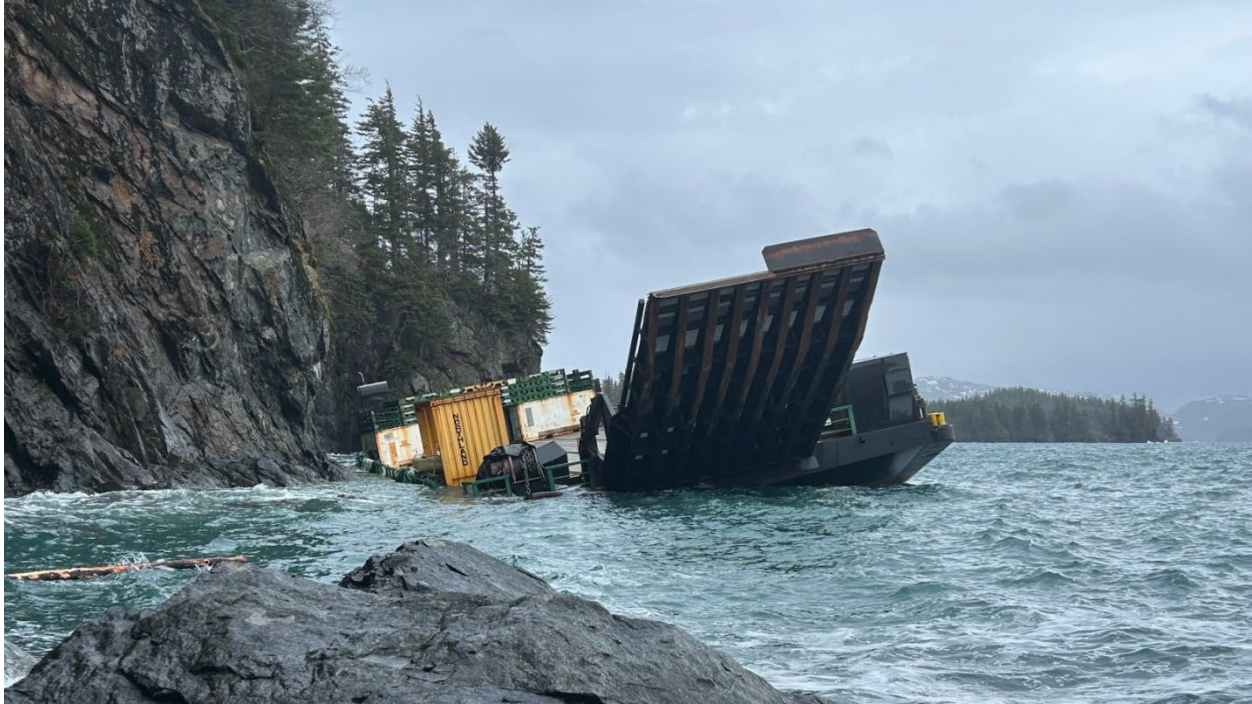
Figure 4. The *Cordova Provider* aground on the rocks at Axel Lind Island on January 14, 2025. (Source: Cordova Provider LLC)

A damage survey of the *Cordova Provider* was conducted while the barge remained grounded on the eastern coast of Axel Lind Island. Based on the extensive hull and structural damage sustained by the barge from running aground on the rocky shore, the *Cordova Provider* was declared a constructive total loss. The barge was towed offshore and scuttled on January 23.

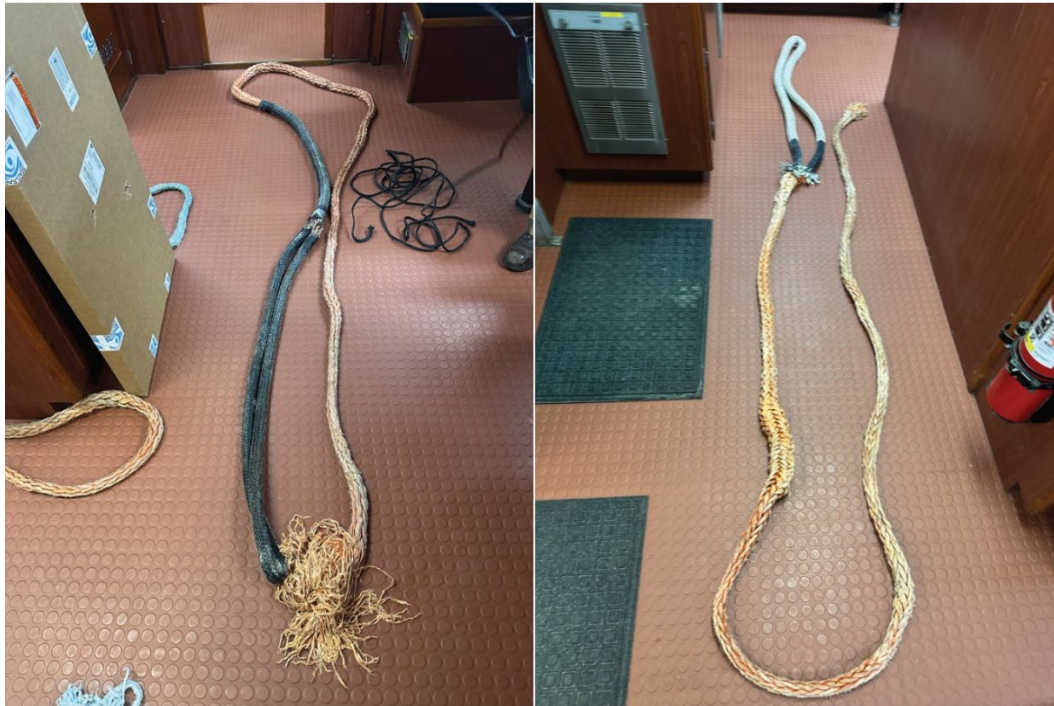
Following the separation of the tug and barge, the crew recovered all the lines except the starboard outboard pennant section. A technician from a local industrial and maritime supply company that assembled the push lines—creating the eyes and adding chafing gear but not manufacturing the lines—visually examined the recovered lines that had parted (see figure 5). The technician found that the lines were in fair to good condition with some light abrasions. The port inboard, port outboard, and starboard inboard push lines all parted at the pennant section, between the soft shackle and line eye connected to the barge. The starboard outboard line parted at the soft shackle (see figure 6). The technician determined that all the push lines and the soft shackle parted due to the lines exceeding their breaking strength (due to a shock or surge load). The exam did not identify any defects or excessive wear that could have contributed to the parting of the push lines.

Figure 5. Left to right: The recovered pennant section of the port outboard and starboard inboard push lines, postcasualty. (Source: Cordova Provider LLC)

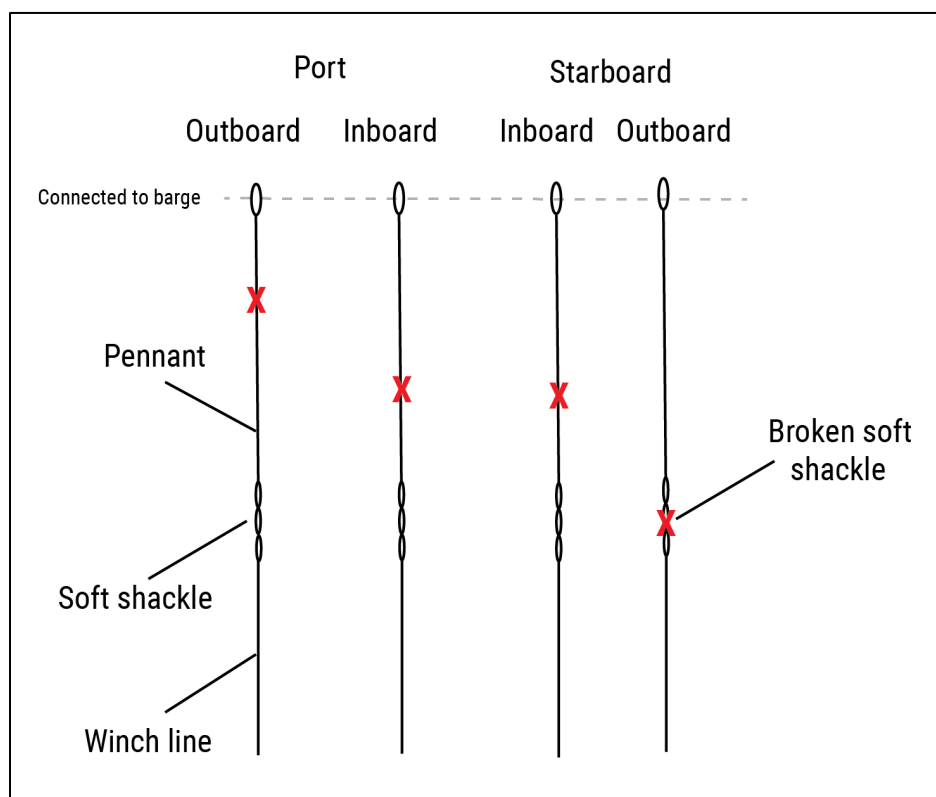
Figure 6. Diagram showing, with a red X, where each of the push lines parted. (Background source: Cordova Provider LLC)

When the lines parted, the seas were 4–6 feet with about 35-knot winds on the vessel's port quarter, weather conditions that the vessel regularly encountered on its normal transit route. Since it was nighttime when the incident occurred, the mate and crewmember in the wheelhouse did not see what caused the lines to part or which line parted first. Five days before the casualty, the captain visually inspected the four push lines and noted no deficiencies. A postcasualty visual inspection of the recovered lines by a technician from a local industrial and maritime supply company found that the lines were in fair condition with no visible deficiencies and determined that all the push lines and the soft shackle parted due to the lines exceeding their breaking strength, likely due to shock loading. Given that the ITB was in regularly encountered conditions and the lines were reported as properly rigged, it is undetermined how the first push line that parted was shock loaded. Once the first push line parted, this likely began a cascading failure as the remaining three push lines took up the additional strain.

The National Transportation Safety Board determines that the probable cause of the grounding of the barge *Cordova Provider* was due to shock loading that led to the parting of the push lines connecting the *Cordova Provider* to the tug *Krystal Sea*.
