July 28, 2025

MIR-25-31

## Fire aboard Yacht *Flagship*

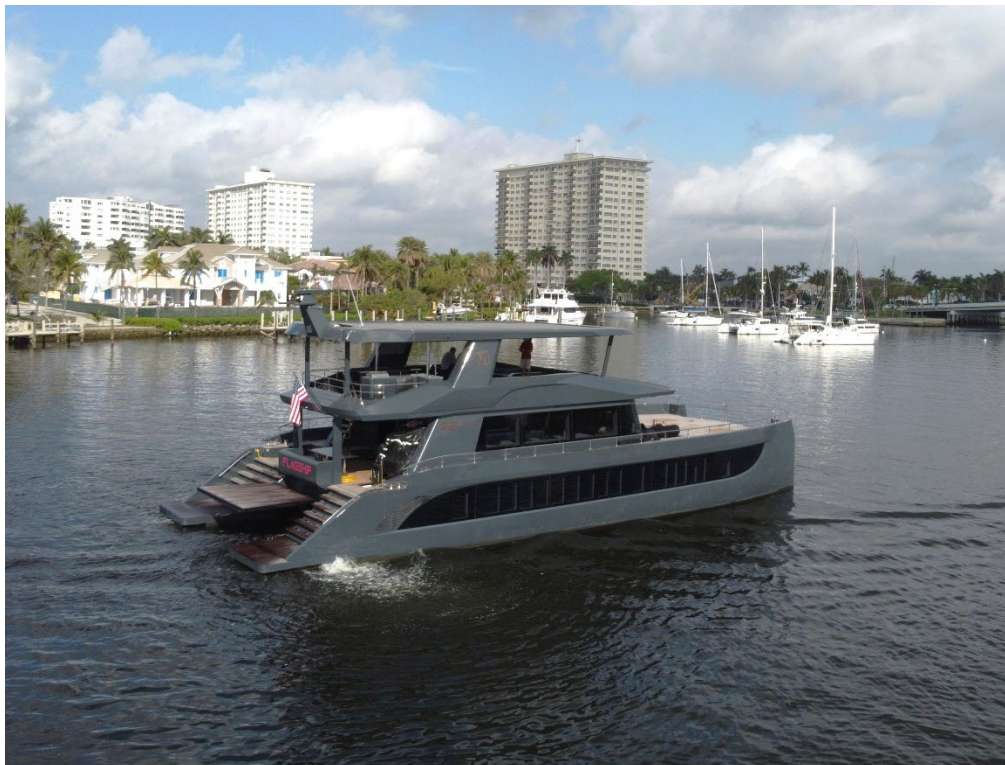
**Figure 1.** The *Flagship* before the fire, on unknown date. (Source: Flagship Marine LLC)

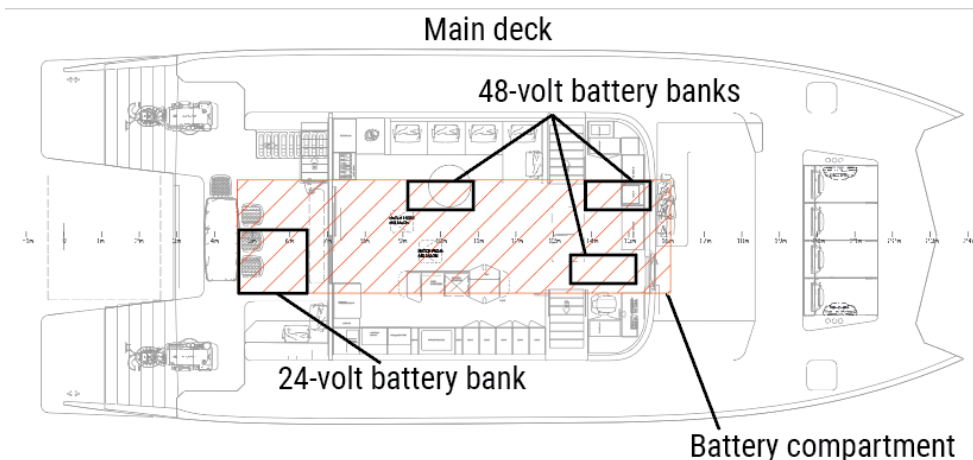
The vessel had three 48-volt lithium-ion battery banks and one 24-volt lithium-ion battery bank—each monitored by a separate battery management system (BMS), a computer system designed to ensure efficient and safe operation of the electrical battery system (see figure 3). A BMS is critical to the safety and overall performance of lithium-ion batteries. The four BMSs aboard the *Flagship* managed the voltage, current, and temperature of each battery cell, as well as the charging and discharging. The BMSs were designed to start charging each of the battery banks when the charge level fell below 94% and would continue to charge until the charge level reached 100%. The battery banks could be charged from the vessel's generator, shore power connection, or the solar panels located on the flying bridge.<sup>4</sup>

**Figure 3.** Diagram of the main deck of the *Flagship* showing the approximate locations of the 24-volt and 48-volt lithium-ion battery banks. (Background source: RMK Merrill Stevens)

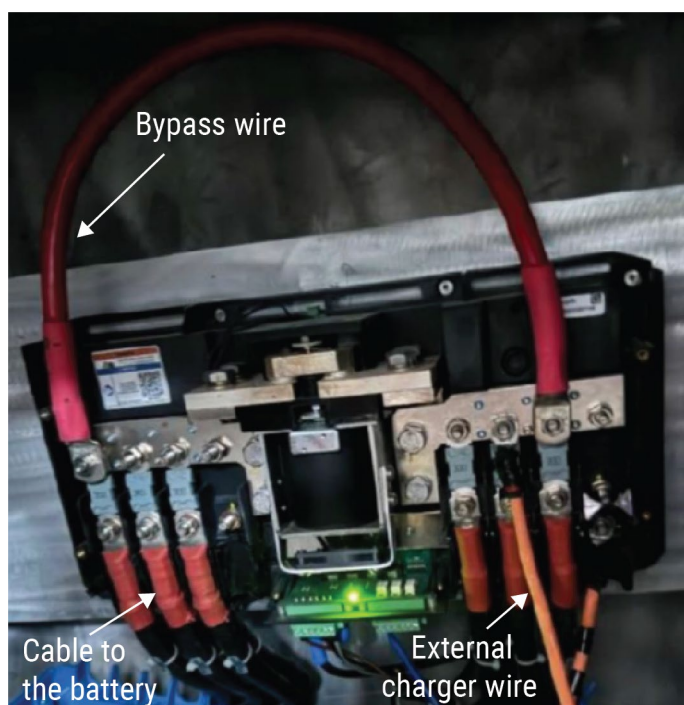
The vessel remained in Fort Lauderdale until January 19, 2024, when it was towed to the RMK Merrill Stevens Shipyard in Miami to address outstanding issues, including water leaks from the flying bridge, and to prepare for the Palm Beach International Boat Show. After the *Flagship*'s arrival at the shipyard, three 48-volt, 60-hertz portable battery chargers were purchased and placed on board the vessel to maintain the charge of the three 48-volt lithium-ion battery banks. However, the charging speed was slow; during the initial charging of one of the 48-volt battery banks using one of the portable chargers, which started on February 1, it took 5 days for the battery voltage to increase from 34 volts to 39 volts. Vessel personnel determined that the BMSs were preventing the batteries from being charged from a portable charger (the thermal bar/contactor on each BMS was not remaining closed). In response, the vessel manufacturer, shipyard personnel, an electrician, and the vessel owner's representative developed a new procedure to increase the charging speed of the lithium-ion batteries by bypassing the BMS of each battery bank. To bypass each BMS, an electrical wire was attached to allow power to travel from one side of the terminal to the other side (see figure 4).

**Figure 4.** The installed bypass wire and the wire from the external charger on one of the 48-volt battery management systems on board the *Flagship*. (Background source: RMK Merrill Stevens)

Since the vessel's arrival in the US, the BMSs for the battery banks of the 24-volt system and the three 48-volt battery systems were inoperable; they did not safely monitor and maintain the charge level of the batteries. This problem with the BMSs was not immediately resolved. In the interim, the vessel manufacturer, shipyard personnel, an electrician, and the vessel owner's representative developed a new procedure to increase the charging speed of the lithium-ion batteries by bypassing the BMS of each battery bank. A wire was attached to bypass each BMS so the batteries could be manually charged at a faster pace by an external charger. As a result, the charge level within the vessel battery banks was not automatically maintained by the BMSs, and, due to an unidentified electrical drain within the vessel, the batteries became fully discharged (0% charge) on several occasions for extended periods. In addition, routinely charging the batteries using a portable battery charger could have resulted in overcharging, since the external battery charger was not connected to and monitored by a BMS and the battery charge level was instead monitored by personnel at the shipyard. Therefore, the practice of externally charging the lithium-ion batteries without resolving the BMS issues resulted in fluctuations in the level of charge on the battery bank.

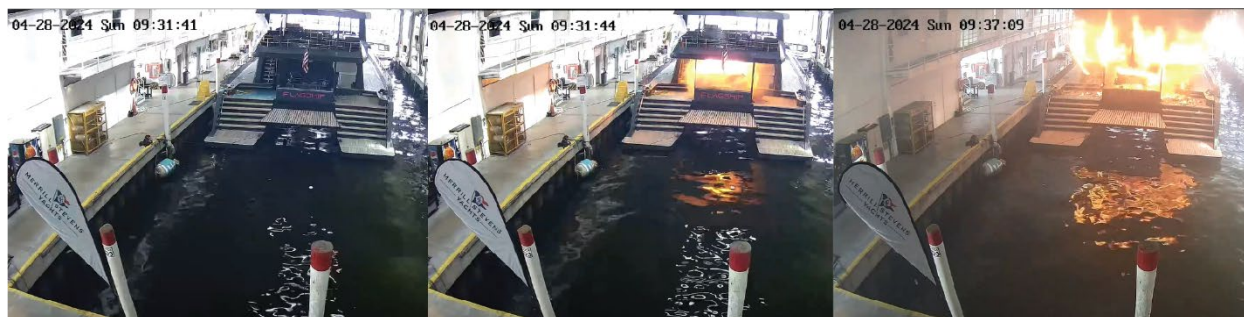
On April 28, the shipyard security cameras recorded an explosion at 1031 on board the *Flagship*, originating from the hatch that led to the 24-volt battery bank (it was a Sunday, so no workers were present) (see figure 5). Following the explosion, smoke was visible, followed by fire. Shortly thereafter, the fire grew rapidly, engulfing the vessel. The shipyard's sprinkler system activated to protect the facility and other vessels from the flames.

**Figure 5.** Left to right: Video still images from the shipyard's internal security camera showing (1) the *Flagship* moored within the facility before the fire (2) an explosion from the aft area of the vessel at 1031 (3) progression of the fire within the vessel. The times in the upper left of each video still are 1 hour behind the actual time because the shipyard clocks were not set for daylight savings time. (Source: RMK Merrill Stevens)

The video from the security camera at the shipyard showed an explosion at 1031 that originated from the hatch for the space below the floor where the 24-volt lithium-ion battery bank was located. The explosion expanded from the hatch and into the interior of the vessel. Following the explosion, smoke and fire were visible on the *Flagship*, and the fire continued to grow, eventually engulfing the entire vessel. Investigators later identified extensive damage to the aluminum deck and hull

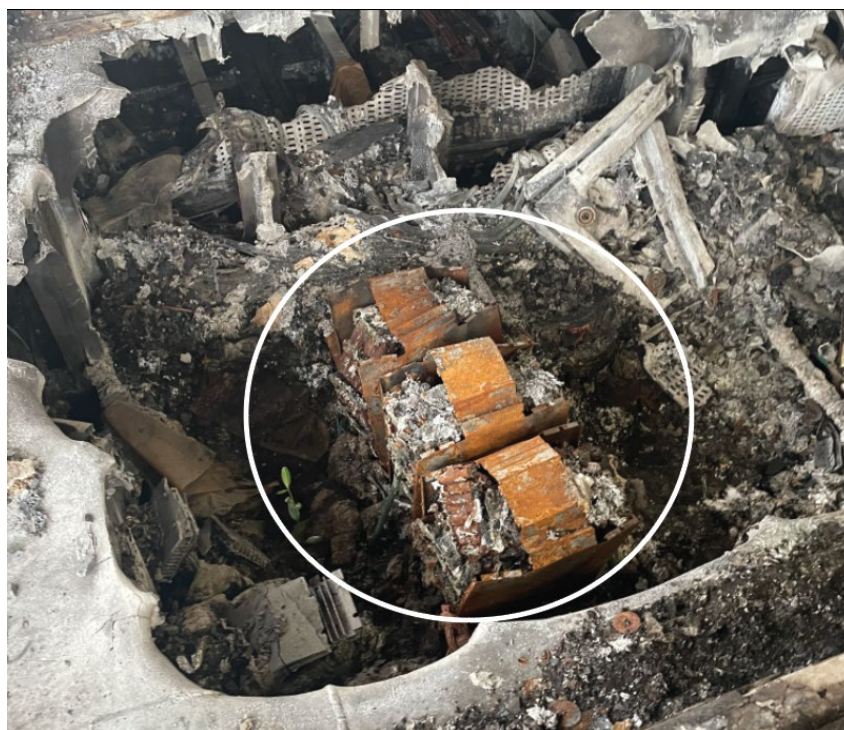
### 1.3 Additional Information

**Figure 6.** The 24-volt lithium-ion battery bank (circled), after the fire.

structure in the area around and above the location of the 24-volt lithium-ion battery bank. Based on the security video and the location of the most extensive fire damage, a lithium-ion battery cell within the 24-volt battery bank was most likely the initiating source of the explosion and fire.

Extensive fluctuation in the level of charge within the batteries may have caused one of the cells to become unstable, eventually resulting in thermal runaway. A thermal runaway occurs when a battery cell overheats and combusts; it is a chemical reaction that can occur to any type of battery cell if it is damaged, shorted, overheated, defective, deep discharged, or overcharged. The heat produced from a thermal runaway of a lithium-ion battery cell can exceed 1,100°F, which can easily cause the adjoining cells of the same battery bank to ignite, as well as cause significant damage to aluminum structures. Lithium-ion battery cell explosions are typically caused by a thermal runaway. Therefore, the explosion on the *Flagship* was likely the result of one of the cells of the 24-volt battery bank undergoing a thermal runaway.

The National Transportation Safety Board determines that the probable cause of the fire on the yacht *Flagship* was the thermal runaway and explosion of the 24-volt lithium-ion battery bank due to the inoperable battery management systems, resulting in the practice of manually charging the lithium-ion batteries with a portable battery charger, which compromised the safe monitoring of the vessel's lithium-ion battery systems.
