# Crane Wire Failure on Offshore Construction Vessel *Island Venture* and Subsequent Damage to Offshore Supply Vessel *C-Enforcer*

On April 3, 2025, about 2145 local time, the offshore construction vessel *Island Venture*'s crane was being used to lift a wire reel from the back deck of the offshore supply vessel *C-Enforcer* in Bayou Lafourche, Port Fourchon, Louisiana, when the crane's hoisting wire parted, causing the reel to drop onto the *C-Enforcer*'s main deck (see figure 1 and figure 2).<sup>1</sup> There were no injuries, and no pollution was reported. Damage to the *C-Enforcer* and *Island Venture* was estimated to be \$3.8 million.

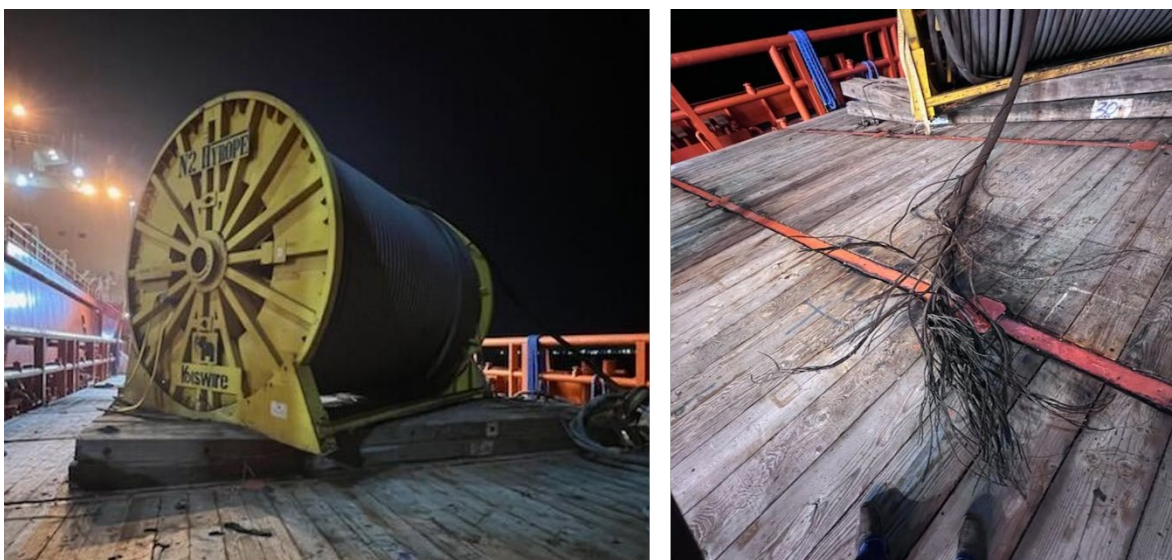
After about 15 minutes, the crane operator stopped the lift to allow the ballast system aboard the *Island Venture* to even the trim.<sup>3</sup> After about 5 minutes, once he had ensured the load was straight (vertical), the crane operator proceeded with lifting the wire reel. When the reel was 5-10 feet above the deck, the main hoisting wire parted about 70 feet from the base of the crane block socket, causing the wire reel to fall onto the main deck of *C-Enforcer* (see figure 4).

**Figure 4.** Fallen wire reel on *C-Enforcer*'s main deck (left) and parted hoisting wire rope (right). (Source: US Coast Guard)

After the wire parted, its recoil damaged a hydraulic line on the upper crane pedestal on the *Island Venture*. Sensing the drop in hydraulic pressure, the crane's safety system stopped hydraulic fluid flow. The rigging crew on the *C-Enforcer* and the crane operator on *Island Venture* were uninjured.

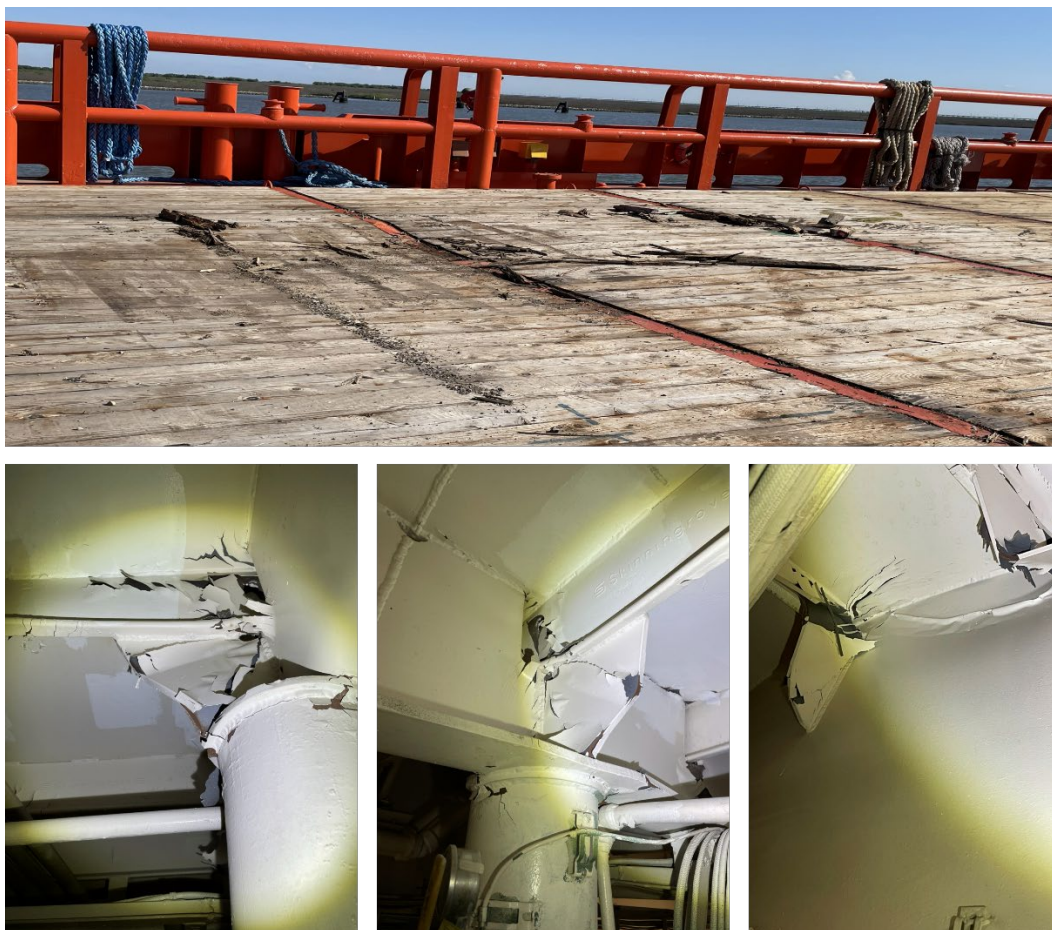
At the request of Edison Chouest Offshore, on April 4, a damage surveyor boarded the *C-Enforcer* to assess the damage to the vessel. The surveyor's preliminary report noted damage to the main deck plating, deck boards, upper framing of engine room (beneath the main deck), various upper engine room piping, and the upper portion of a liquid mud tank (see figure 5).

**Figure 5.** Damage to *C-Enforcer* main deck (top) and framing of upper engine room and liquid mud tank (below).

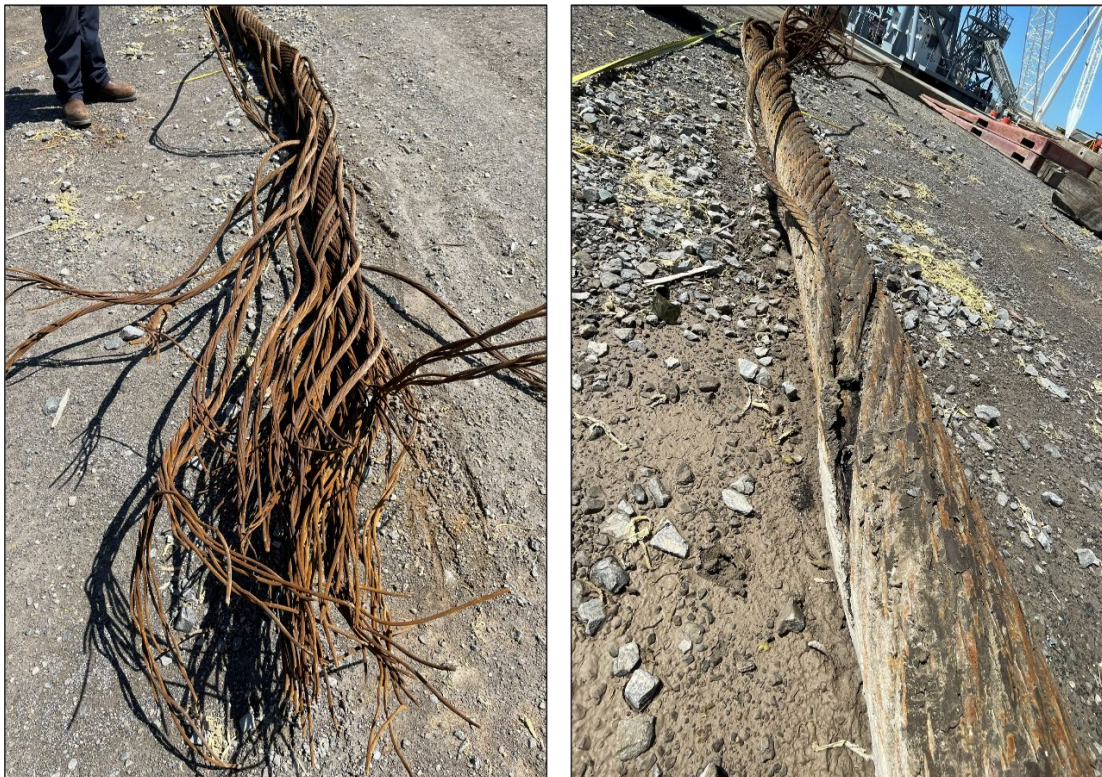
After the casualty, Coast Guard and National Transportation Safety Board investigators visually examined the parted hoisting wire and the remaining wire on board *Island Venture* (see figure 6). The hoisting wire showed internal and external oxidation (rust). The outside diameter of the wire had minimum and intermittent aged lubrication grease coverage throughout the length.

**Figure 6.** Parted hoisting wire that fell with wire reel onto deck of *C-Enforcer*.

After the casualty, the parted hoisting wire was visually examined by Coast Guard and National Transportation Safety Board investigators. The visual examination revealed oxidation (rust) of the external and internal strands of the hoisting wire. The outer layer of the remaining hoisting wire on board that was examined had minimum and intermittent aged grease coverage. The hoisting wire had been in service for 8 years, and during its service life, the wire was used in subsea operations and exposed to salt water, salt air, and humid conditions. These conditions can strip the lubricating grease from a wire, and, if salt water is not removed, it can cause oxidation and/or corrosion. Because the wire was 13,451 feet (4,100 meters) in length, a visual examination for corrosion would have been difficult to complete. Instead, a sample of the wire was regularly break-tested to verify its breaking strength and, thus, whether corrosion could be present. The hoisting wire had two break tests over its life (the last occurring 9 months before the casualty). Once the company identified that the wire's breaking strength had decreased from its original breaking strength, they derated the crane to a SWL of 320 MT.

The National Transportation Safety Board determines that the probable cause of the failure of the hoisting wire on the offshore construction vessel *Island Venture*'s crane was internal corrosion of the crane's hoisting wire.
