# Flooding and Sinking of Fishing Vessel

## *North American*

On May 14, 2024, about 0550 local time, vessel representatives for the fishing vessel *North American*, which was uncrewed and docked on the Lake Washington Ship Canal, in Seattle, Washington, were notified that the vessel was flooding. Salvors arrived on scene and attempted to dewater the vessel but were unable to keep up with the flooding, and the vessel eventually sank (see figure 1 and figure 2).<sup>1</sup> There were no injuries, and no pollution was reported. Damage to the vessel was initially estimated at \$3 million.

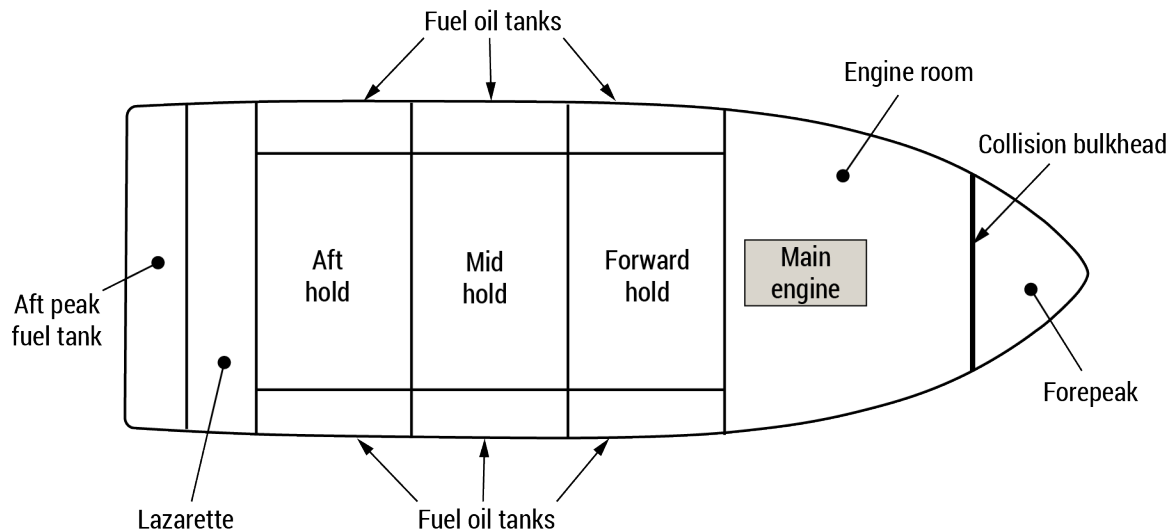
The hold/machinery level (below deck) was divided by six transverse watertight bulkheads into seven compartments (see figure 4). Forward was a forepeak with the engine room aft; the two spaces were separated by a collision bulkhead. Aft of the engine room was the first of three centerline floodable holds (forward, mid, and aft), and fuel oil tanks in the wings and double bottoms below them.

**Figure 4.** Representation of the *North American* hold/machinery level based off precasualty survey and photos. (Not to scale.)

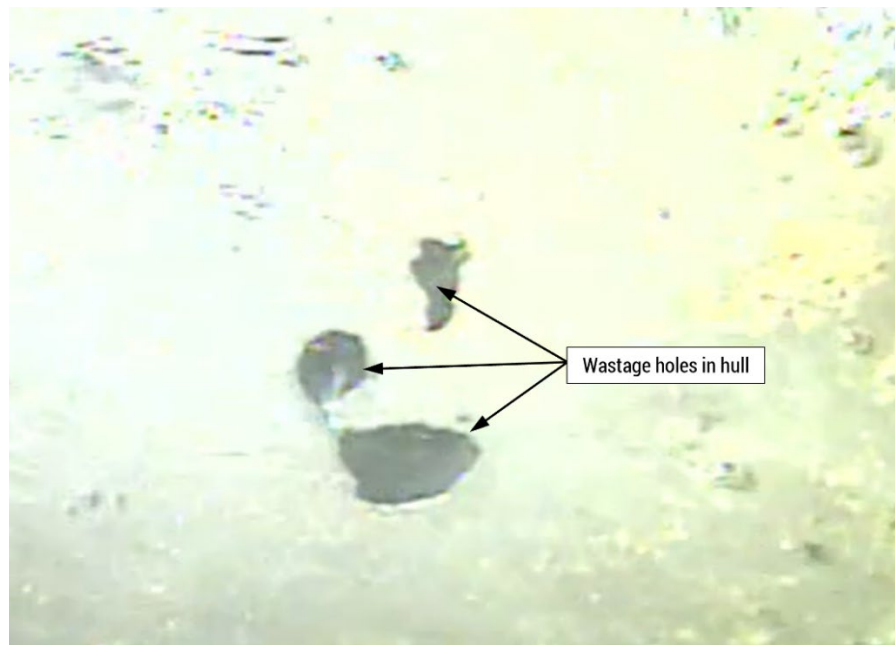
A dive survey was conducted after the sinking. The diver noted that there did not appear to be any issues with the rudder post or shaft, stern tube, or the cutlass bearing for the propeller shaft. He also checked all the sea chests and found no problems. While examining the hull, he found three wastage holes, “all smaller than a silver dollar,” located 56 inches to the port of the keel and 99 inches aft of the outboard sea chest, placing them in the shaft alley (see figure 5).

**Figure 5.** Wastage holes discovered in hull during postcasualty survey. (Background source: Global Diving)

The paint on and around this area was found to be in excellent condition. No dishing or deflections were found in this area either. No witness marks or any type of damage from a potential grounding were found in this area or anywhere on the vessel ... .

A postcasualty dive survey found three wastage holes in the hull. The diver found no other potential sources of water ingress after examining the entire hull, the rudder, propeller, and all thru-hull fittings (including the stern tube). The crewmembers did not report striking any objects or grounding during their sea trial, and the dive survey confirmed that there were no signs of collision or grounding. Therefore, it is likely that the source of the flooding into the shaft alley, and subsequently the engine room, was the three holes in the hull, which were located beneath the shaft alley.

The National Transportation Safety Board determines that the probable cause of the flooding and sinking of the fishing vessel *North American* was hull corrosion, which resulted in wastage holes that allowed water ingress into the engine room overnight while the vessel was unattended.
