# Crane Wire Failure on Offshore Construction Vessel *Island Venture* and Subsequent Damage to Offshore Supply Vessel *C-Enforcer*

On April 3, 2025, about 2145 local time, the offshore construction vessel *Island Venture*'s crane was being used to lift a wire reel from the back deck of the offshore supply vessel *C-Enforcer* in Bayou Lafourche, Port Fourchon, Louisiana, when the crane's hoisting wire parted, causing the reel to drop onto the *C-Enforcer*'s main deck (see figure 1 and figure 2).<sup>1</sup> There were no injuries, and no pollution was reported. Damage to the *C-Enforcer* and *Island Venture* was estimated to be \$3.8 million.

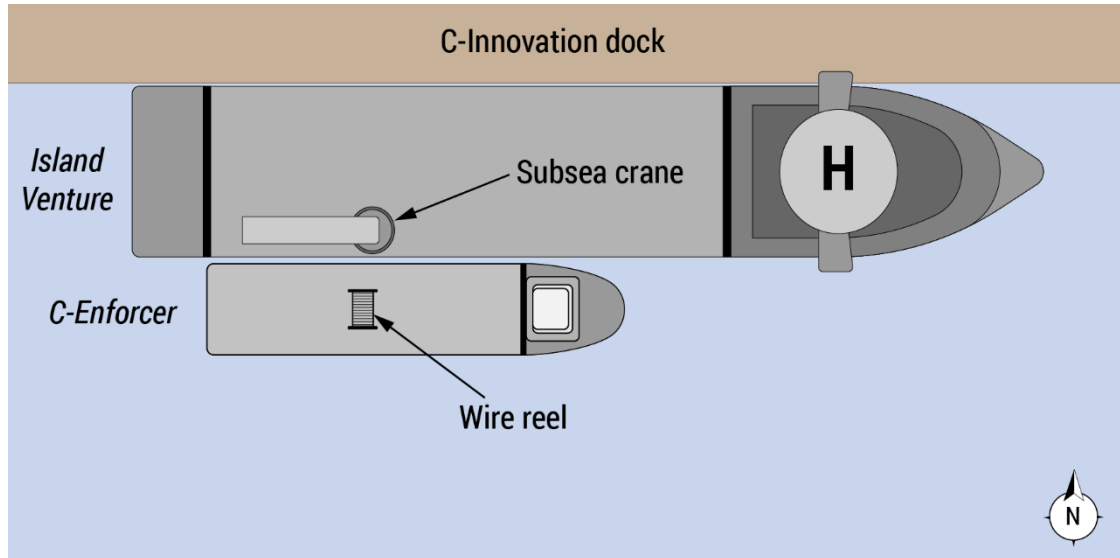
At 1200, the *C-Enforcer* departed E Slip and transited to the C-Innovation dock, where the *Island Venture* was moored. The *C-Enforcer* was positioned alongside the *Island Venture*'s starboard side so that the wire reel could be offloaded by the *Island Venture*'s subsea crane later that evening (see figure 3).

**Figure 3.** Overhead view showing positions of *Island Venture* and *C-Enforcer* at the time of the casualty. (Scale approximate.)
